Fire and Collapse, Faculty of Architecture Building, Delft University of Technology: Data Collection and Preliminary Analyses

ABSTRACT

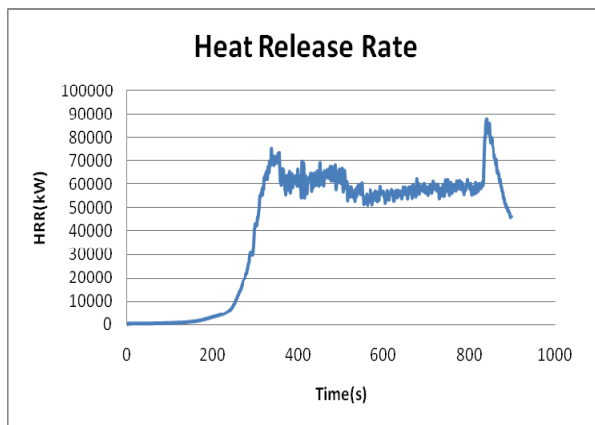
Fig 9. HRR History for Initial Fire

The HRR history of the simulation is shown in Fig. 9. Fig. 10 provides a snapshot of the FDS at 360 s into the simulation. Based on the level of data and information available, it is concluded that it possible to simulate the initial fire conditions with a reasonable degree of confidence.

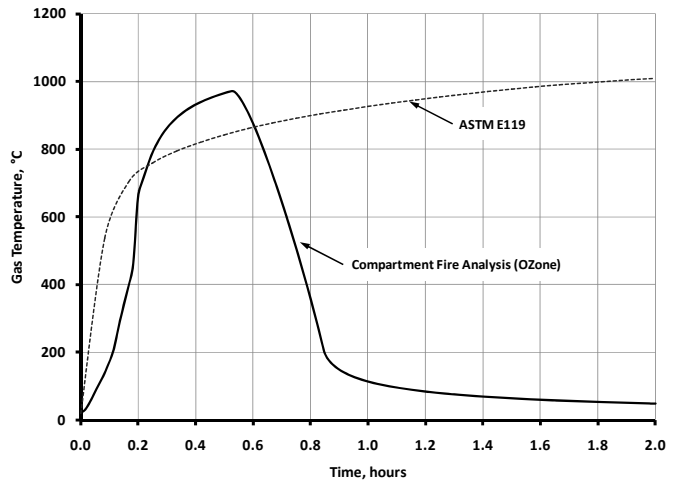
Fig. 13. Typical Result of Compartment Fire Analysis

To estimate temperatures to which the structural members were exposed, simplified compartment fire analyses were conducted for a typical office in the northwest portion of the building. A single-zone approximation was used to characterize post-flashover conditions. A series of analyses were conducted using the computer programs OZone [18] and BRANZFIRE [19]. Published compartment time-temperature curves were also evaluated [20]. Parametric studies were conducted to consider a reasonable range of fire loads, ventilation conditions, and compartment boundary thermal properties. A typical result of such an analysis obtained from OZone is plotted in Fig. 13. Also shown for comparison is the ASTM E119 [21] time-temperature curve. Although the parametric study showed a range of time-temperature curves, the curve plotted in Fig. 13 was representative of the general trends of predicted peak temperatures and duration, and was used for subsequent heat transfer and structural analysis. The predicted peak temperature was on the order of 950°C, and the predicted duration of high temperatures, say greater than about 300°C, was on the order of 30 to 45 minutes. The time frame for which severe burning was observed in any given location on the northwest wing from photo and video evidence seems to suggest these predicted durations are reasonable.

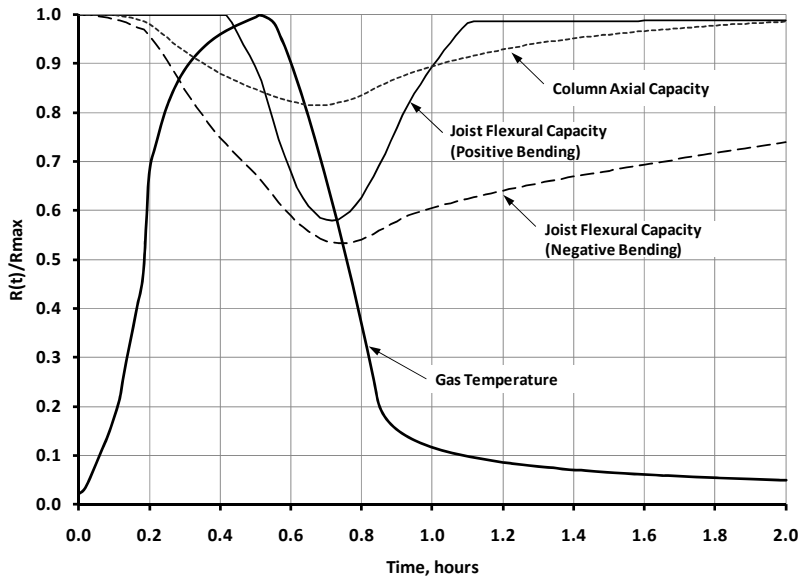
Fig. 14. Normalized Cross-Section Capacities of Joist and Column

Representative results of member cross-section capacity analyses are shown in Fig. 14. This figure plots cross-section capacity as a function of time for three cases: joist flexural capacity for positive bending (tension on bottom), joist flexural capacity for negative bending, and column axial capacity. The gas temperature versus time curve that was used for this analysis is the OZone generated curve shown in Fig. 13. Note that the gas temperature-time curve is also plotted in Fig. 14. In Fig. 14, all quantities are normalized to their peak values. Gas temperatures are normalized to the peak gas temperature, which occurs approximately 30 minutes into the analysis. Member cross-section capacities are normalized to the capacities at 20°C. Thus, for example, a normalized capacity of 0.80 indicates that the cross-section retains 80-percent of its capacity at normal temperature.

the members are at their weakest condition well into the cooling phase of the fire. This plot also shows that the most significant loss of capacity occurs for flexure in the joists. This significant loss of flexural capacity may be the result, in part, to the rather small concrete cover in these members. Note that the loss of axial capacity in the columns is rather small. The columns always retained more than 80-percent of their normal axial capacity throughout the analysis.

The member capacity plots in Fig. 14 show that as gas temperature increases, member capacity decreases. Similarly, as the gas temperature decreases, the members begin to regain capacity. The analysis predicts that the members reach their minimum capacity about 45 minutes into the analysis. At this point, the gas temperature is well past its peak (which occurs at 30 minutes) and has already cooled substantially. Thus,

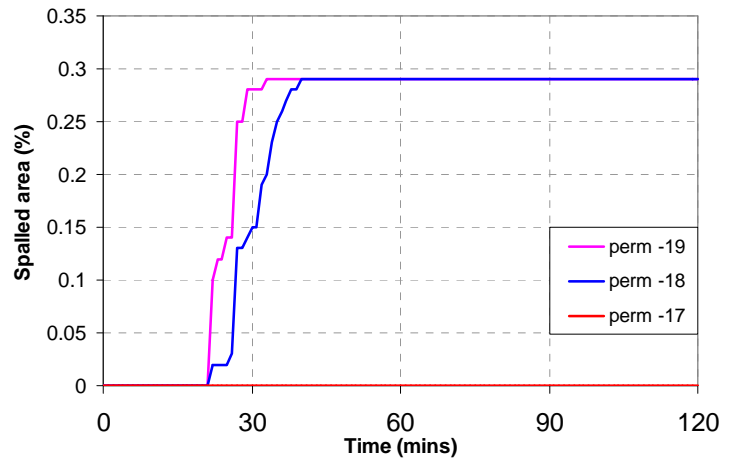
Fig. 15 Progression of spalling

Results from the analysis indicate that when a permeability of 10^{-17} is assumed, no spalling occurs and the RC column survives burn-out condition. When the permeability is changed to 10^{-18} spalling is predicted to start in the 22nd minute of fire exposure and stops at about 40 minutes into the fire. At this time most of the cover concrete is lost, but the column in this case also did not fail. About 28.5% of the column cross-section was predicted to have spalled off. The survival of the column can be

attributed to the fact that by the time the column lost enough mass due to spalling and lost strength due to degradation of material properties, the fire was in the decay phase and the column could regain its strength. This column could be said to have just marginally survived the fire. With a permeability of 10^{-19} spalling starts a bit early at 21 minutes in the fire exposure and stops in 35 minutes. This column fails in 43 minutes into fire exposure. As stated, spalling progressed faster in this column and thus when the cover of concrete was lost the fire temperature were at its peak and thus the column could not sustain the applied load. Figure 15 shows the progression of spalling for the three permeability values. Figure 16 shows the area of cross-section lost in the column at 30 minutes (temperature peak) of exposure and 50 minutes (burnout) of exposure.

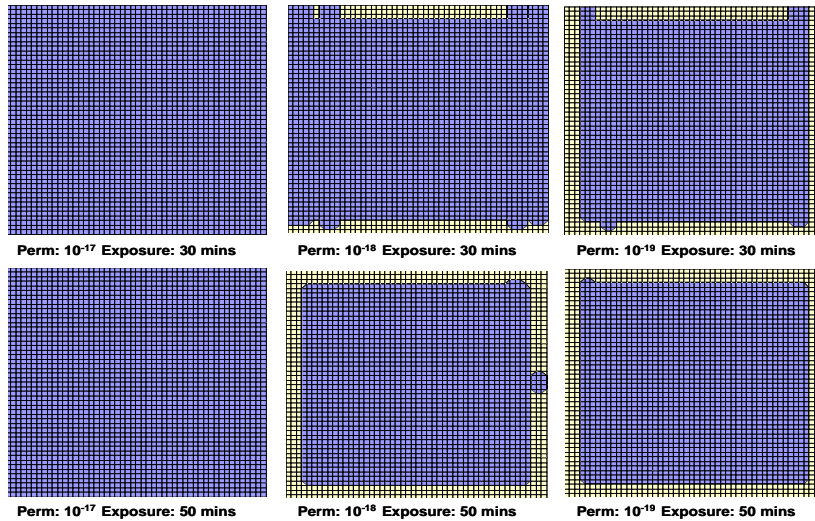
Fig. 16 Loss of cross-section due to fire induced spalling

A review of post-fire photographs of the FOA building indicates loss of cross-sections in certain parts of the buildings. This was postulated to be due to fire induced spalling. As a preliminary analysis, the above MSU model was applied to analyze a typical reinforced concrete (RC) column from the TUD building to predict the extent of spalling and fire resistance. The selected column is of 500 mm square cross-section and of 3 m length. The RC column was assumed to have a reinforcement comprising of 4-32 mm bars. The column was assumed to carry a load of 400 KN (40% of its load carrying capacity at room temperature) at the time of fire incident. The column was made of concrete of cube strength of 300 kg/cm² (cylinder strength of 25 MPa) and the reinforcement having a yield strength of 400 MPa. Also, the column is said to have bent ties (135° bent to the concrete core). The compartment fire shown in Fig. 13 was used as the fire scenario in the analysis. Since the permeability of concrete in the column is not known, fire resistance analysis was carried out by assuming three different orders of permeability (10^{-17} , 10^{-18} , 10^{-19}).

The above analysis illustrates the possibility of fire induced spalling in RC columns leading to structural collapse. However, it should be noted that fire response modeling of concrete structures, as well as prediction of spalling, is very complex and is highly dependent on the input parameters (high temperature properties, fire temperatures etc). For this a detailed analysis is required and efforts in that direction are currently underway by the authors.
