Fire and Collapse, Faculty of Architecture Building, Delft University of Technology: Data Collection and Preliminary Analyses

ABSTRACT

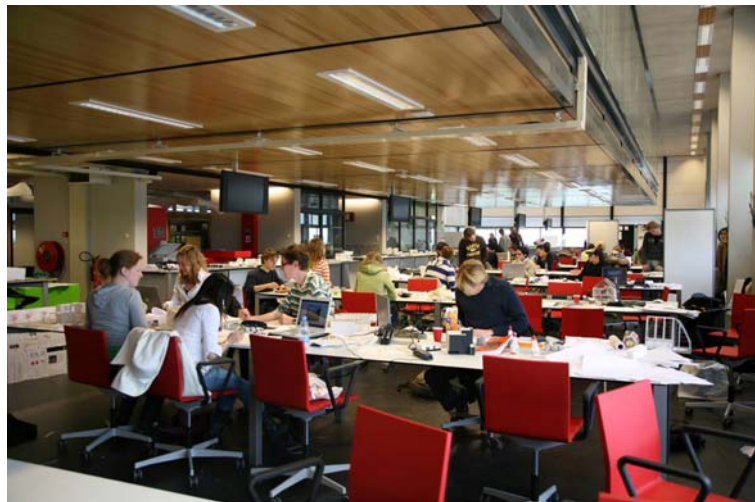
Fig. 4. Photograph of double-height studio with mezzanine floor, furniture and materials typical of Faculty of Architecture building at time of fire [9].

might be expected based on current code requirements. As described earlier some portions of the double height floors had mezzanine levels that were hung from the floors above (Fig. 4). These mezzanines were constructed with a structural steel floor system, and were hung from the reinforced concrete joists using steel rods.

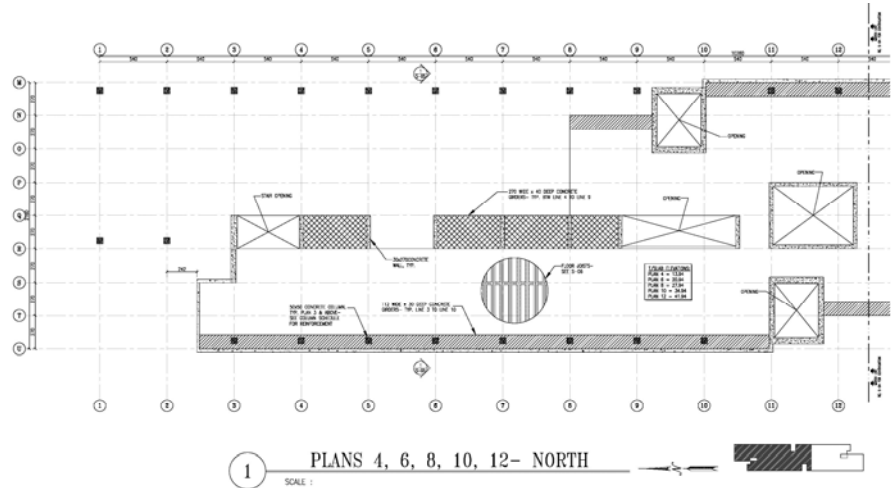
Fig. 11. Structural Elements, Tower, North End, Typical Floor

The FOA Building was a reinforced concrete structure that used mild (non-prestressed) steel reinforcement. The specified cube compressive strength of the concrete was 300 kg/cm^2 . For the tower, some basic elements of the structural system can be seen in Fig 3. A more detailed drawing of the north portion of a typical floor in the tower is shown in Fig. 11, which was re-drafted from the original design drawings. The layout of structural members at the south end of the floor is essentially identical to the north, reversed in the east-west direction. Square columns ran along the outer perimeter of the tower, spaced at 540 cm in the north-south direction.

The columns were 50cm x 50cm over the full height of the building, with the amount of reinforcement decreasing with height. Within the middle portion of the tower were a series of walls, also spaced at 540 cm in the north-south direction. Girders running in the north-south direction connected the columns. Girders also connected the walls in the north-south direction. Both sets of girders were wide and shallow sections.

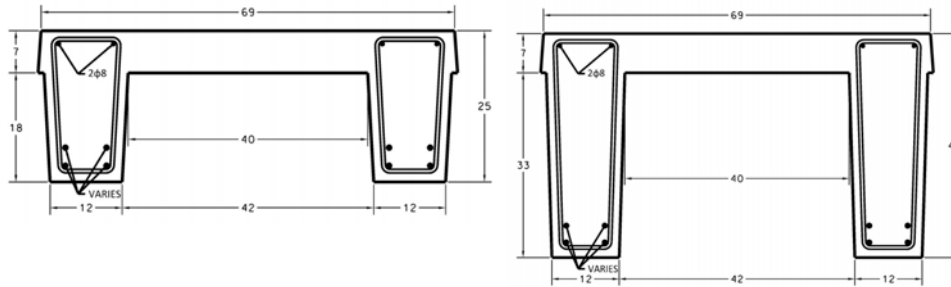
Fig. 12. Typical Floor Joist Details (dimensions in cm)

The floor system consisted of a series of reinforced concrete joists running in the east-west direction between girders. Typical details are shown in Fig. 12. Depending on their location, the joists were either 25 cm or 40 cm in depth. The joist floor system consisted of a series of precast inverted U-shaped sections as shown in Fig. 12. The remaining portions of the floor slab between precast elements were cast-in-place. These cast-in-place portions of the floor were formed with timber. These timber forms were reportedly left in-place after construction was completed, as they were hidden behind a drop ceiling system. One item of particular interest in examining the joist details was the concrete cover, which varied from 15 to 20 mm; somewhat smaller than
